## **FINAL REPORT OF SPECIFIC PURPOSE LIDAR SURVEY**

### **LiDAR, Breaklines and Contours for Brevard County, Florida**

**State of Florida  
Division of Emergency Management  
Contract 07-HS-34-14-00-22-469  
and Add-On Agreement with  
Brevard County, Florida**

**October 30, 2009**

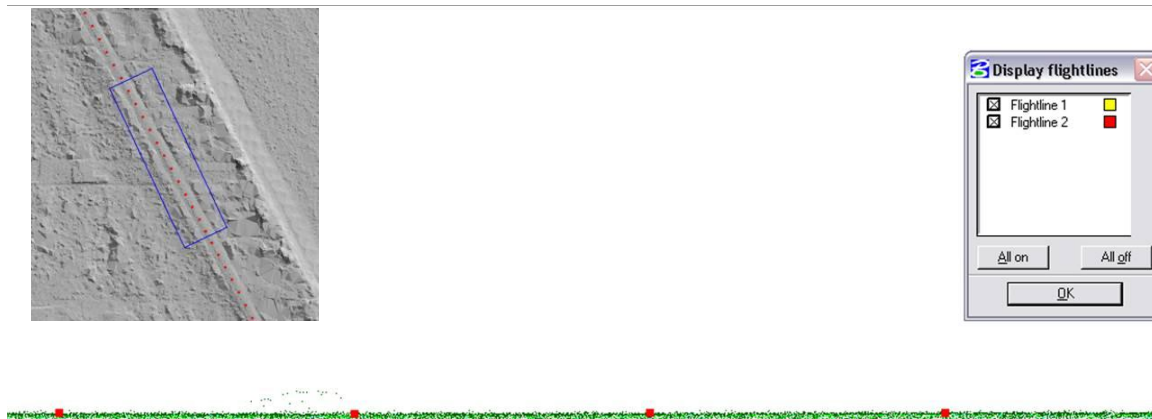
**Figure 3 Example of Control pts (flightline 2) loaded with the raw data to check vertical accuracy**

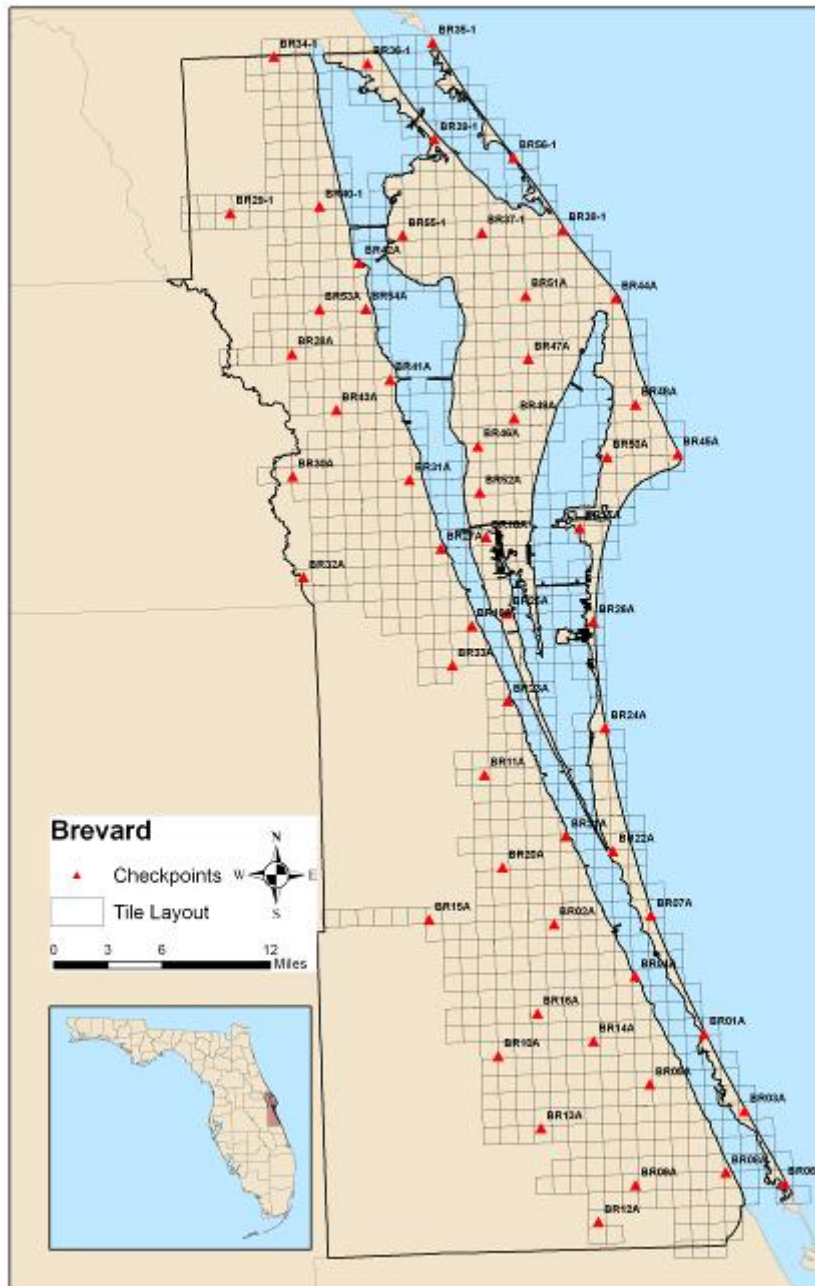
**Figure 1 — Location of QA/QC Checkpoint Clusters for Brevard County**

Figure 1 shows the location of the QA/QC checkpoint clusters within Brevard County. Each point represents a checkpoint cluster. There are nominally four checkpoints in each cluster, one per land cover category.

1. PDS surveyed "ground truth" QA/QC vertical checkpoints in accordance with guidance in references B, C, D and E. Figure 1 shows the location of "cluster areas" where PDS attempted to survey a minimum of 54 QA/QC checkpoints in each of the four land cover categories. Some clusters may not include points from all cover categories. The final totals were 57 checkpoints in bare-earth and low grass; 58 checkpoints in brush and low trees; 54 checkpoints in forested areas; and 54 checkpoints in urban areas, for a total of 223 checkpoints.
2. Next, PDS interpolated the bare-earth LiDAR DTM to provide the z-value for each of the 223 checkpoints.
3. PDS then computed the associated z-value differences between the interpolated z-value from the LiDAR data and the ground truth survey checkpoints and computed the FVA, CVA and SVA values using procedures in References D and E.

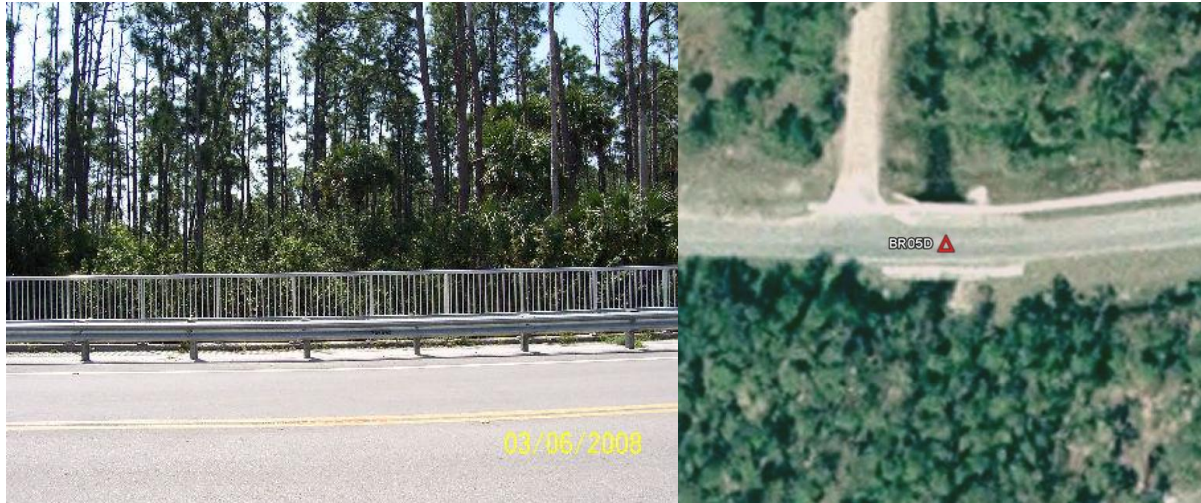
Checkpoint BR05D was located on a bridge deck (see photos below) and was not used in the vertical accuracy assessment.

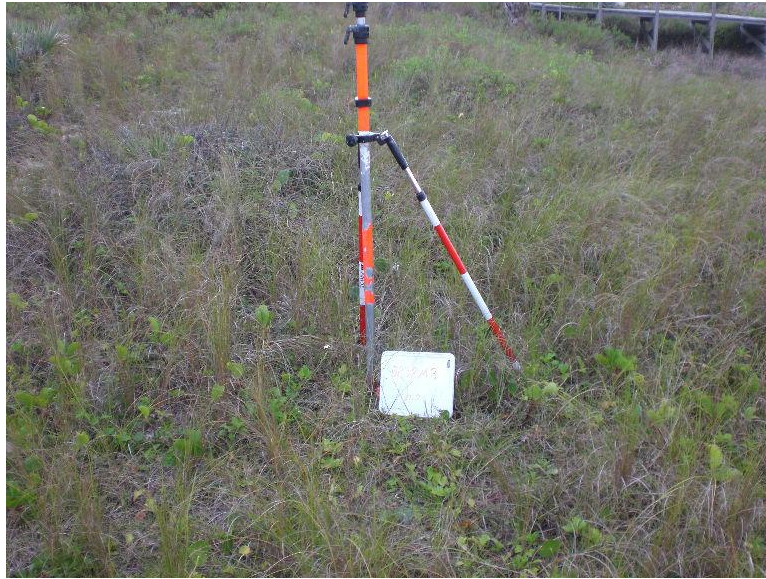
Checkpoint BR38-3 was supposed to located in a forested location, however, there was no forested areas in the vicinity of the BR38 checkpoint cluster. This point was located in tall weeds and included in the CAT 2 Brush and Low Trees classification.

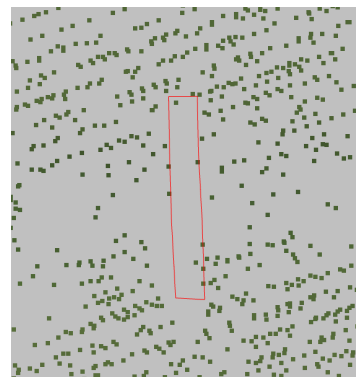
LID2007\_056009\_E

**Figure 11 Tile 056009 – example of points classified as Class 2- ground points on a bridge deck.**

**LID 056009** – in several areas ground points were found in the .LAS files that should have been removed from bridge overpasses (see Figure 5). This was likely due to an automated filter confusing the points with ground points, based on elevation. These tiles were rejected and subsequently corrected by the mapping vendor.

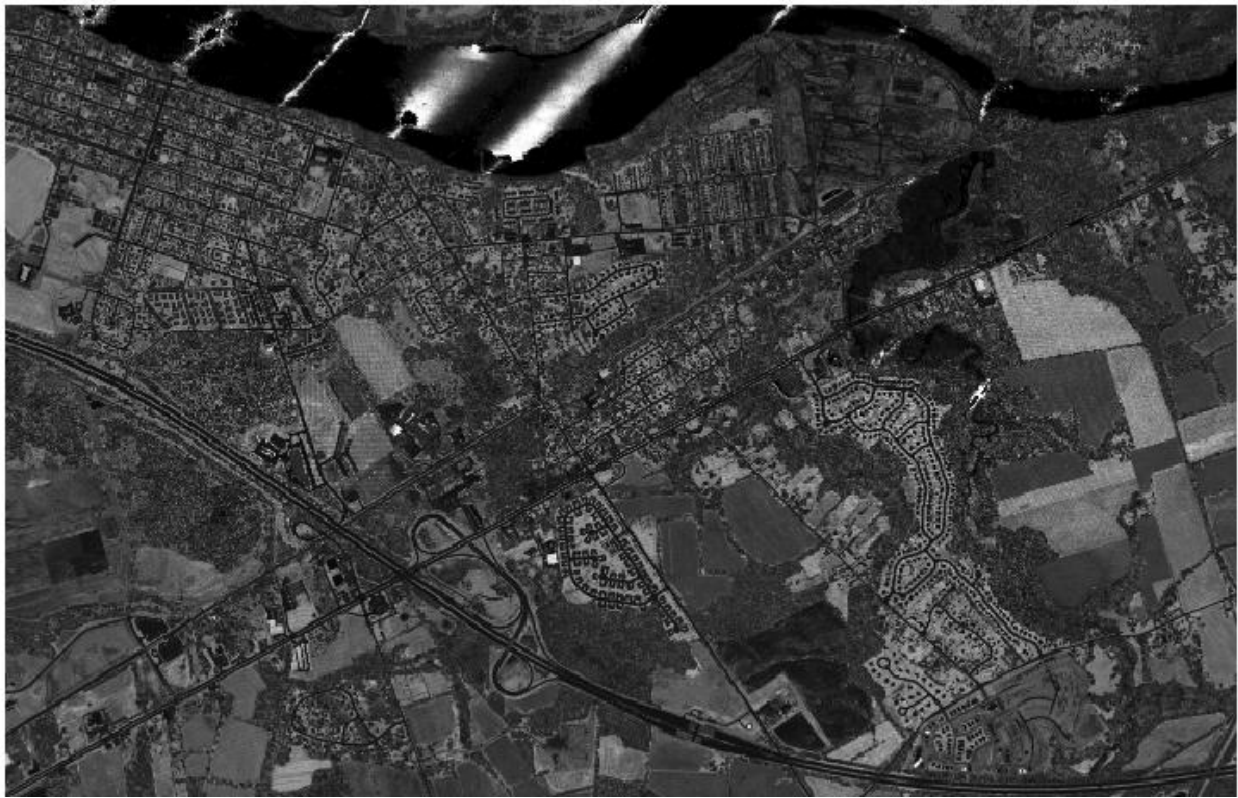
**Figure 13. LiDAR intensity streaks over water and marshy areas**

Figure 13 is an example of a LiDAR intensity image, showing streaks over rivers and areas of standing water; such intensity streaks exist in LiDAR datasets nationwide. QA reviews identified the presence of anomalous LiDAR intensity values within the coastal regions of Brevard County. The PDS team has reviewed the issue and while it was determined that the anomalies do not cause any of the datasets to fall short of the specifications of the project nor do they affect the overall integrity of the data, these anomalies have been corrected in the LAS data. This report documents the root cause, the geographic extent of the anomalies for this county, the geographic extent of areas exceeding the vertical specification of the contract expressed as % of the total county area, and modifications performed on the dataset to correct these anomalies.

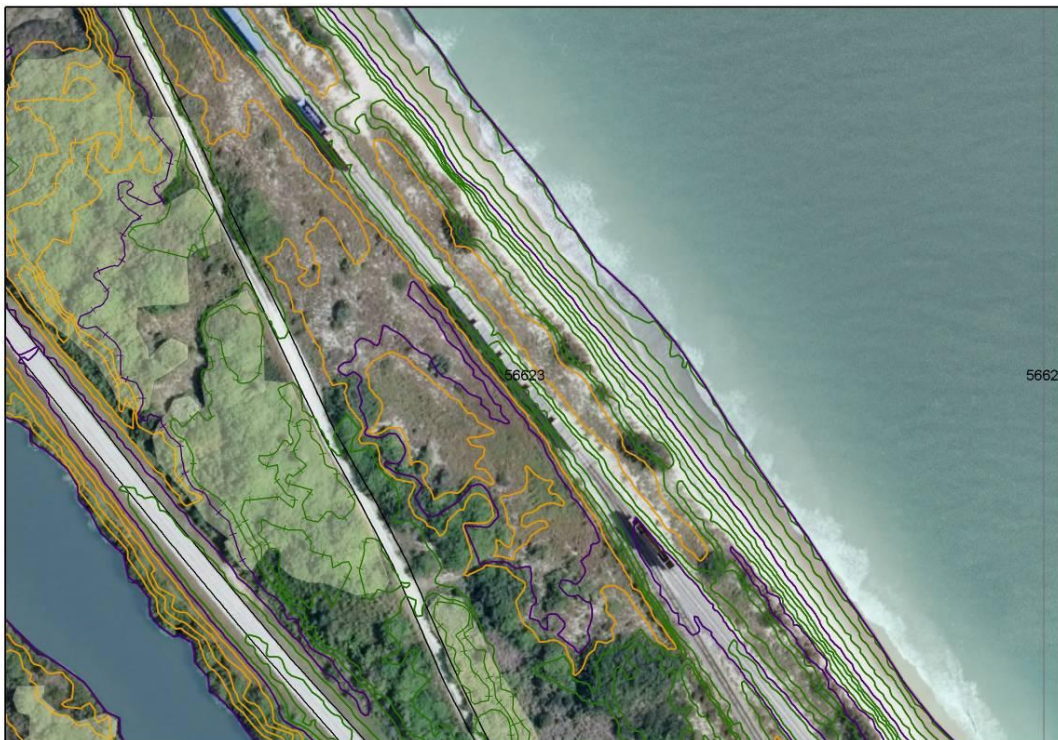
Coastal shorelines are correctly captured as two-dimensional polygon features, extracted from the LiDAR data and not from digital orthophotos, except for manmade features with varying heights such as seawalls which are captured as three-dimensional breaklines. Coastal breaklines merge seamlessly with linear hydrographic features. Shorelines continue beneath docks and piers. There is no “stair-stepping” of coastal shorelines. Figure 1 shows example coastal breaklines and contours.
